USA-CERL TECHNICAL REPORT N-88/06  
April 1988

# Evaluation and Guidelines for the Use of Temporary Wood Buildings at U.S. Army Installations

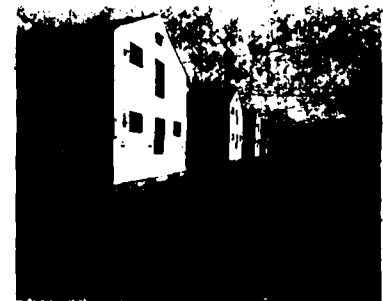
- 4.1.1 External Lighting
  - none, only a firelight
  - street light a security issue: more lighting would give a feeling of greater safety
- 4.1.2 Recreation Areas
  - barracks are near gym
  - have volleyball court
  - facilities judged adequate by users
- 4.1.3 Courtyards
  - need to be blacktopped
  - dust blowing into buildings is a problem in the summer when trucks use the quadrangles
- 4.1.4 Lawns
  - no comments recorded
- 4.1.5 Parking
  - nearest parking : 100 meters from barracks
- 4.1.6 Landscaping
  - none
- 4.1.7 Garbage Bins
  - if dumpsters were closer to barracks users would empty trash more often

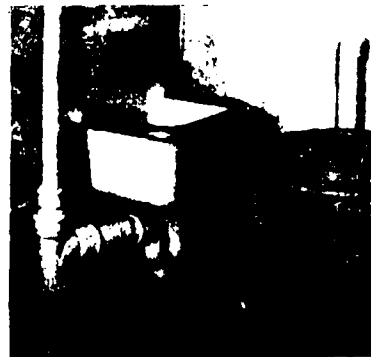
- 4.2.1 Cooking  
- none: not allowed in barracks
- 4.2.2 Laundry  
- washer and dryer in latrine  
- washing tub is sturdy enough but too small for washing field equipment and for wash buckets
- 4.2.3 Ironing  
- individual facilities: OK
- 4.2.4 Storage  
- no comments recorded

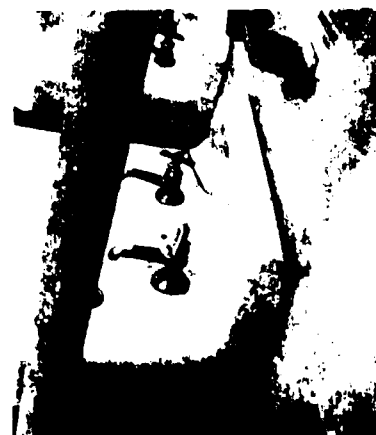
4.5.5

- no backing board- sinks are coming off walls
- would like one faucet for both hot and cold water
